Memorandum

To: File
Prepared: Rolando H. Briones, Jr., P.E., Engineer of Record (EOR)
Date: July 1, 2025
Re: Somerset College Academy, Proposed Drainage Improvements

I. Football Field & Track Field: Areas 1, 2, 3

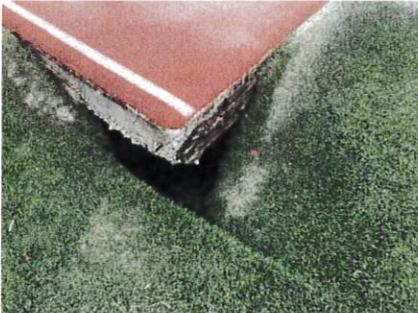
Area 1 Failure

- a. **Area 1:** The Track and Field finished surface is covered with synthetic material. Overtime stormwater—from cumulative rain events—has led to the undermining of the track. The final amount to be repaired will be determined after the initial excavation.
- b. The synthetic carpet shows multi failure depressions that are observable. The extent of these areas cannot be determined from the surface.
- c. When the original natural grass was removed a French drain was installed or possibly removed with the installation of the synthetic field. This drain does not appear to be include in the referenced drawing. The design plans will need to indicate this possibility.

Corner of Running Brad Jump Track.

- a. The underground piping and trench drain need to be televised. This will reveal the extent of the damaged and how much to repair.
- b. The last two junction boxes need to be replaced with prefab boxes. (6'x6' junction box and 48" diameter manhole (MH) should be replaced with a prefabricated junction box.
- c. The 30" HDPE that's laid across the track should be replaced with a 36 L.F. section of 36" R.C.P., eliminating any possible joint under the track field and withstanding any pounding of large rocks inside the pipe. This will require replacing a section of the track surface & base.

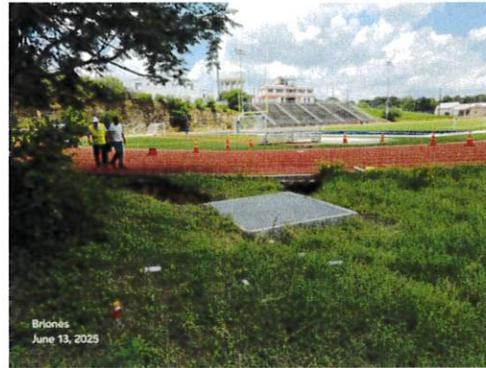
Area 2 Failure

- d. **Area 2:** The above described observations seem to culminate at an existing junction box that collects the Trench Drain from the southern half of the football field. It then feeds the larger diameter line that flows into another and much larger junction box located outside the circular running track. This failure area is referenced as Area 2.
- e. **Area 3:** is located between the large junction box and the upstream junction box located to the west in the grass area outside the circular track. This failure appears to be on the surface.

We have not checked on the condition of the spillway at the creek. The 6'x6' grated junction box is in bad condition with part of the outlet pipes blown out by the force of the discharge. Part of the box's vertical walls were also blown out. The 6'x6' J' box looks like it standing only on 2 vertical walls, instead of 4 walls.

Existing grate inlet/junction box.

The results of the televise of pipe will determine if any portion of the existing piping system need replacement. We would recommend replacing the grate inlets with 4-way inlet and surrounding the 4-way inlets a flared concrete apron.

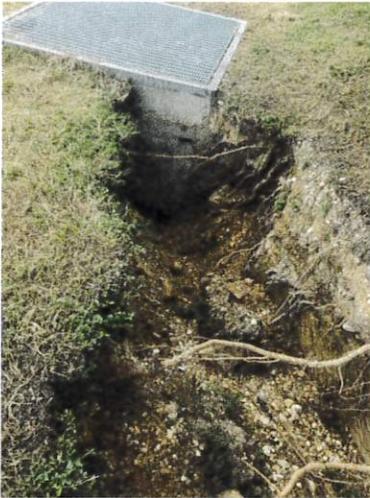
Area 3 Failure

The second and significantly larger failure Area 2, in the grass area outside of the circular track in the southeast corner between the fence and circular track. Area 3 is located upstream of Area 2 and ending at an upstream combination grate inlet, junction box.

Surface failure upstream of Failure Area 2.
